# Kalgoorlie-Boulder Odour Impact Investigation

## Odour Sources Identification

Prepared for: City of Kalgoorlie-Boulder

January 2025

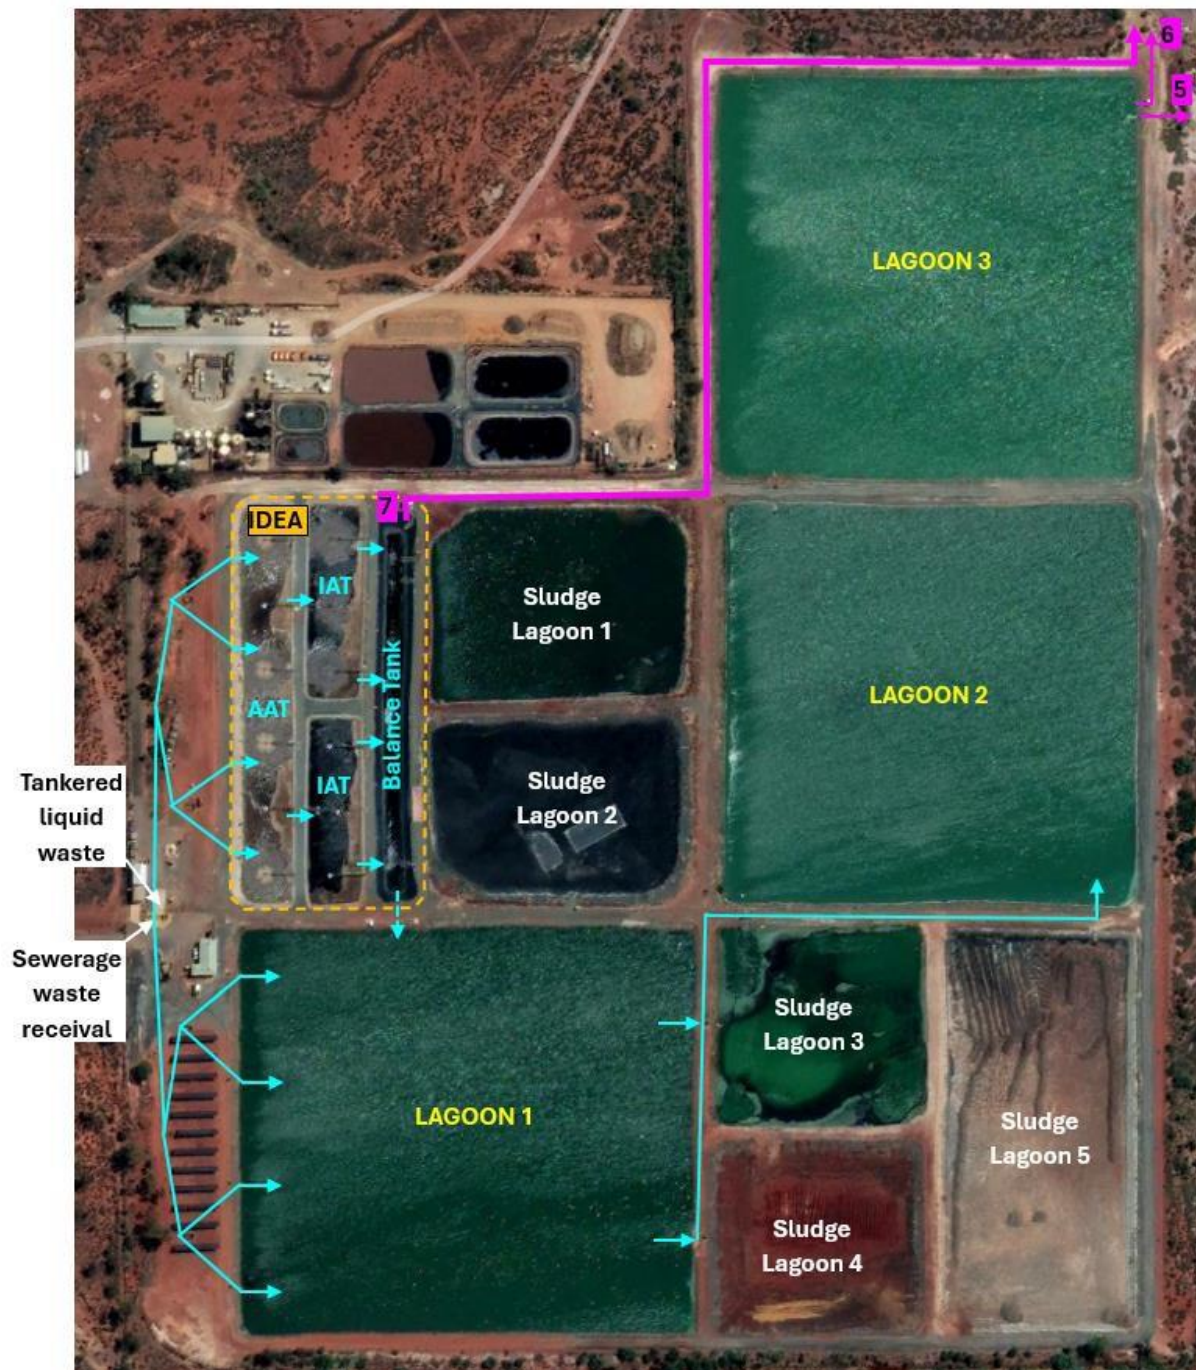
**Figure 3:** SBWWTP prior to 2020

By April 2022, Lagoon 1B was filled with wastewater, and Lagoon 2 received a new liner by June 2022. In July 2022, Lagoons 1A, 1B, and 2 were filled with wastewater, while Lagoon 3 was refilled with water by August 2022.

With the commissioning of the new lagoons, the gradual decommissioning of the IDEA system began. Between July and December 2022, raw wastewater was directed to Lagoons 1A and 1B for six hours per day. The proportion sent to the Lagoons increased up to April 2023 when the total wastewater throughput was directed to Lagoons 1A and 1B, allowing for the decommissioning of the IDEA system.

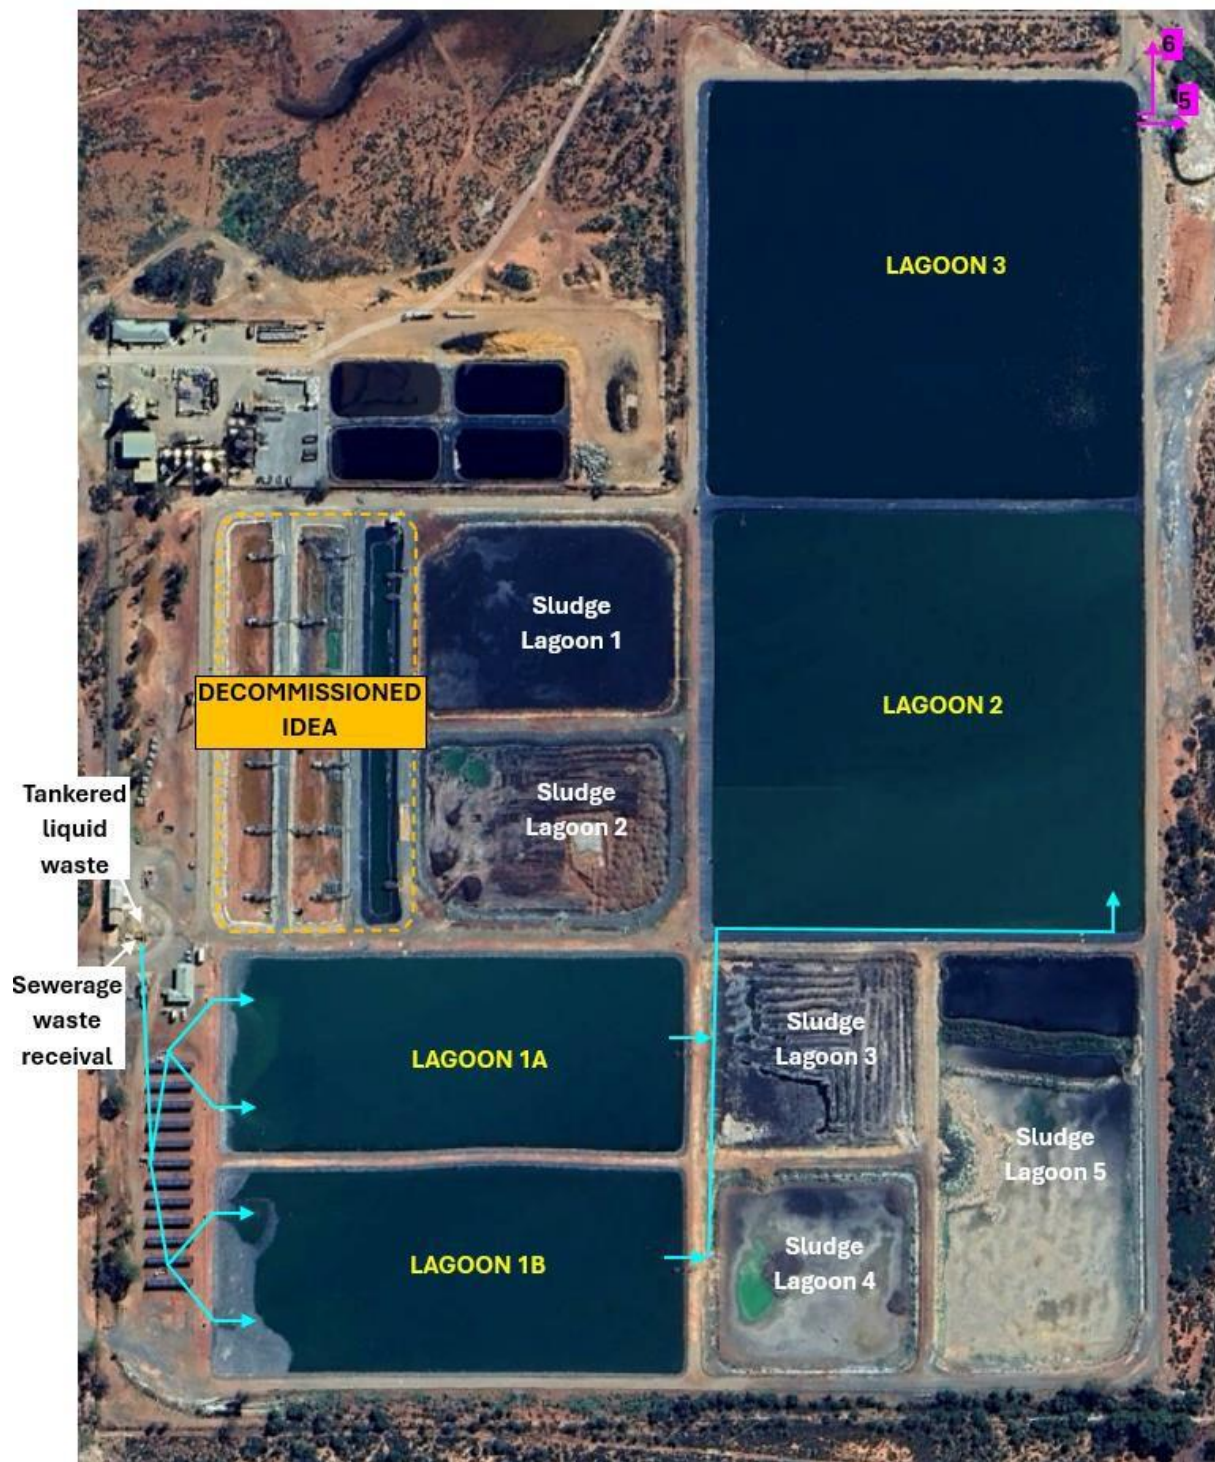
**Figure 4:** Current configuration of the SBWWTP

The new facility transitioned from a mechanical treatment to a pond treatment system with a daily throughput of about 6 ML/day.

**Figure 4** presents a view of the current facility with the IDEA decommissioned and the full throughput treated through the pond system.

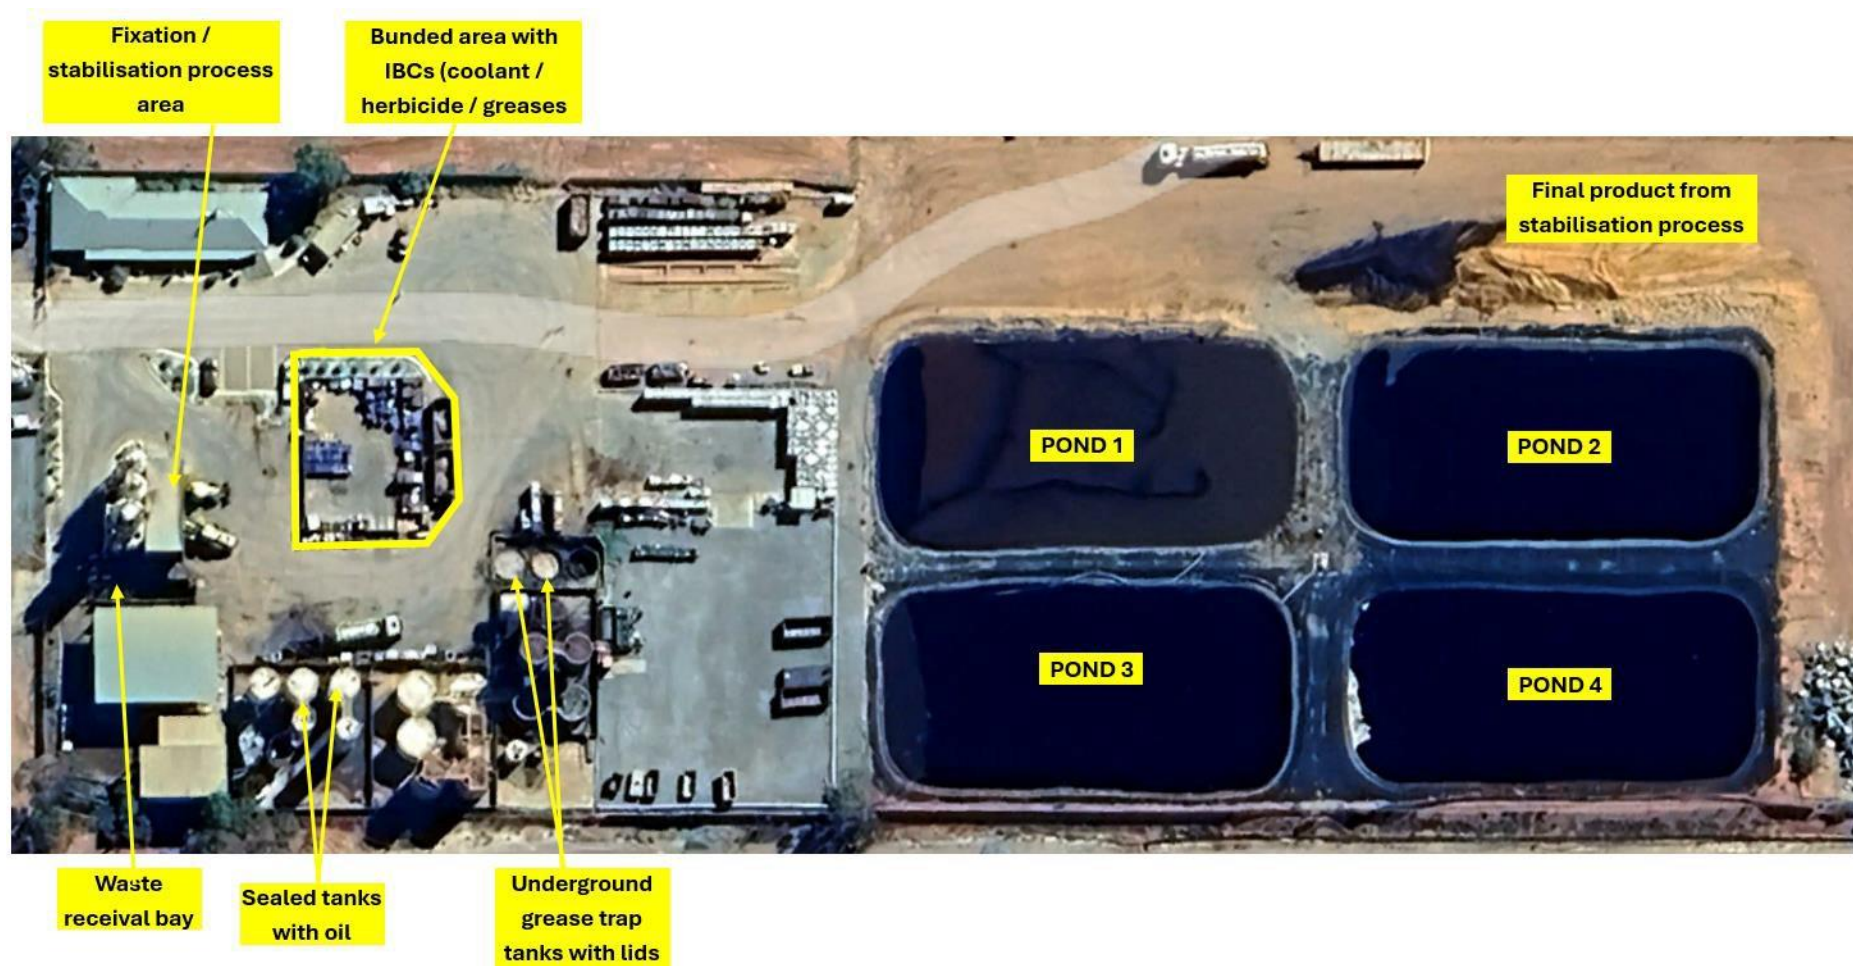
**Figure 11:** WRR layout and main operations

During a site visit on 21 October 2024, OPAM Consulting conducted pH monitoring. The equipment used was not optimal for measurements near the edge due to a thick oil layer observed on the water's surface. This oil layer likely limits the water's exposure to the atmosphere, significantly reducing the evaporation rate.

Additionally, the thick oily layer on the water surface likely reduces evaporation rates and may hinder the removal of some pollutants at higher pH levels. Chemicals are applied to the ponds to regulate and maintain the pH within the desired range.

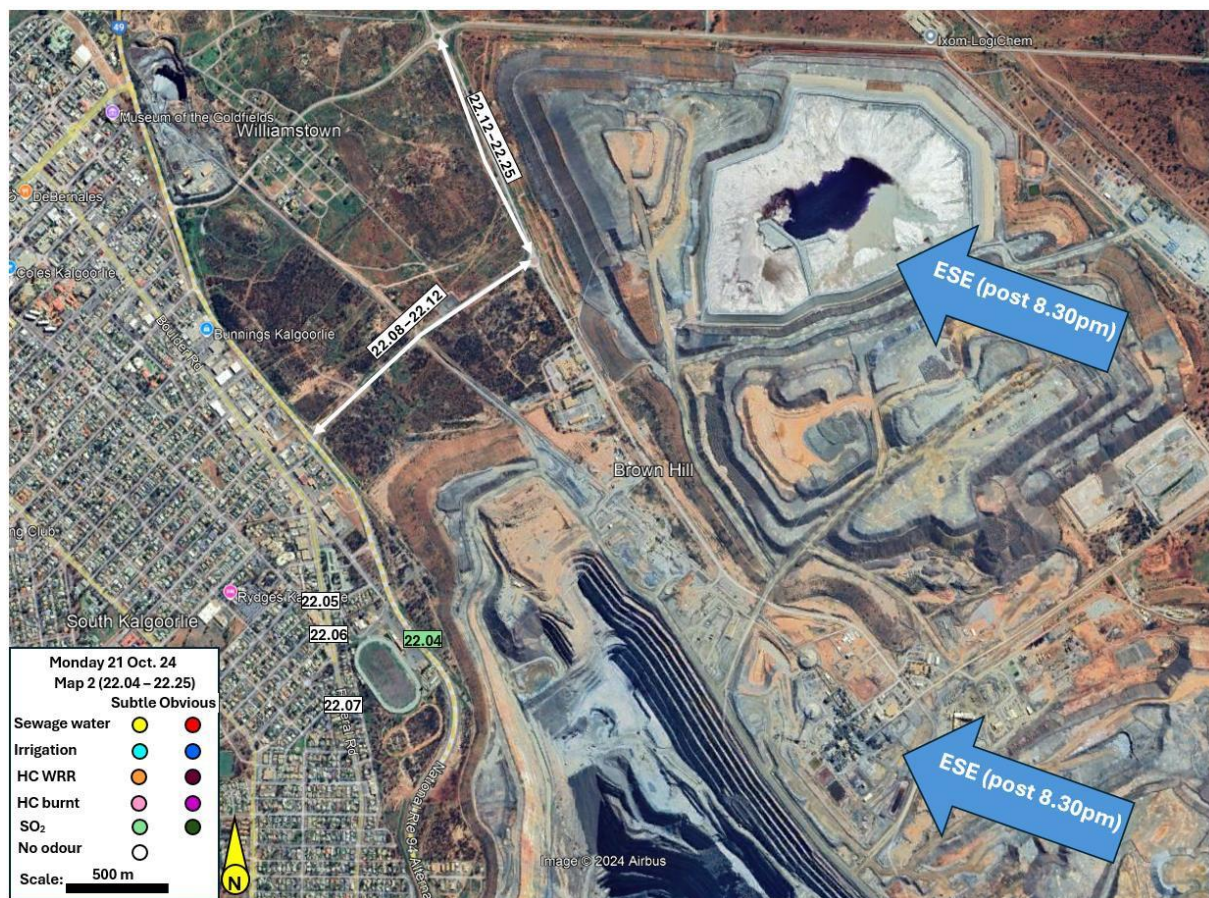
**Figure 15:** Odour Map 2 (OP #1)

- Corner of Federal Road and Short Street (22.05),
- Corner of Federal Road and Harvey Street (22.06), and
- Corner of Federal Road and Tupper Street (22.07).

Boorara Road (22.08 to 22.12) and Black Street North (22.12 to 22.25) were also patrolled, downwind of the northern tailings pond. No odour was detected in these areas.

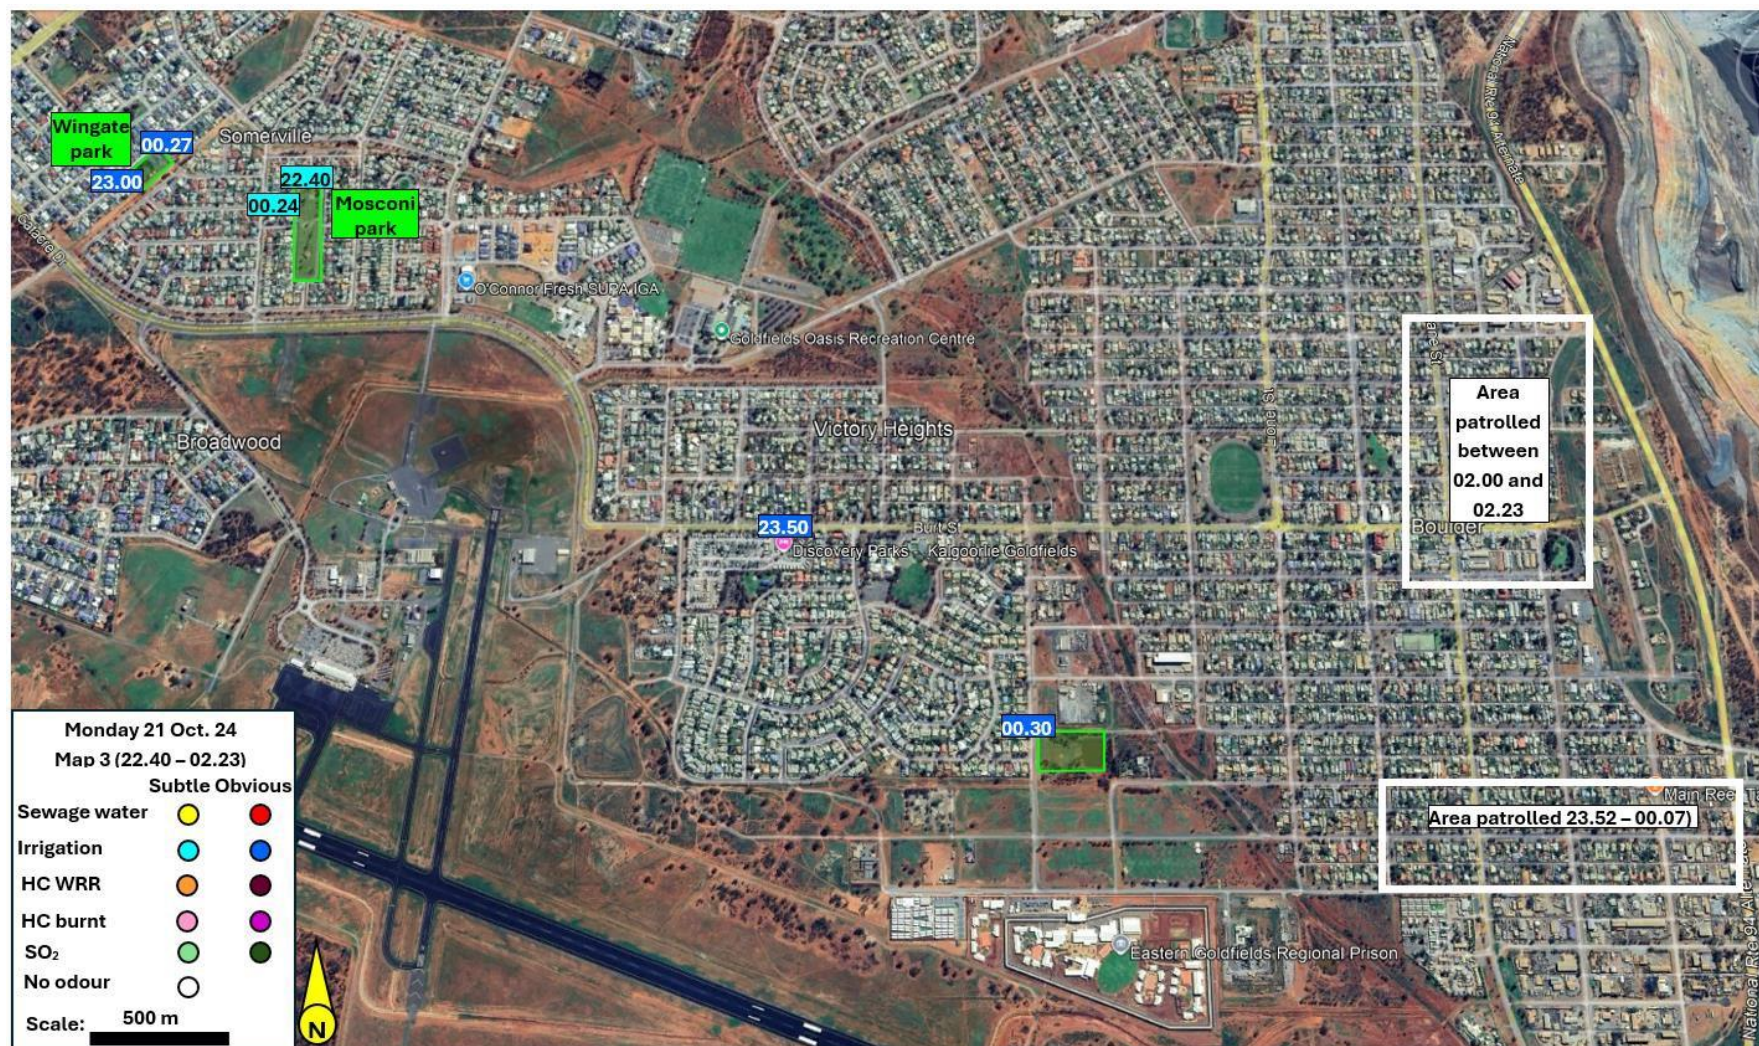
Figure 16: Odour map 3 (OP #1)

The low level of odour from the recycled water used at Mosconi Park may not be a nuisance for surrounding residents. However, the level and character of the odour at Wingate Park and Dwyer Park would likely trigger odour reports.

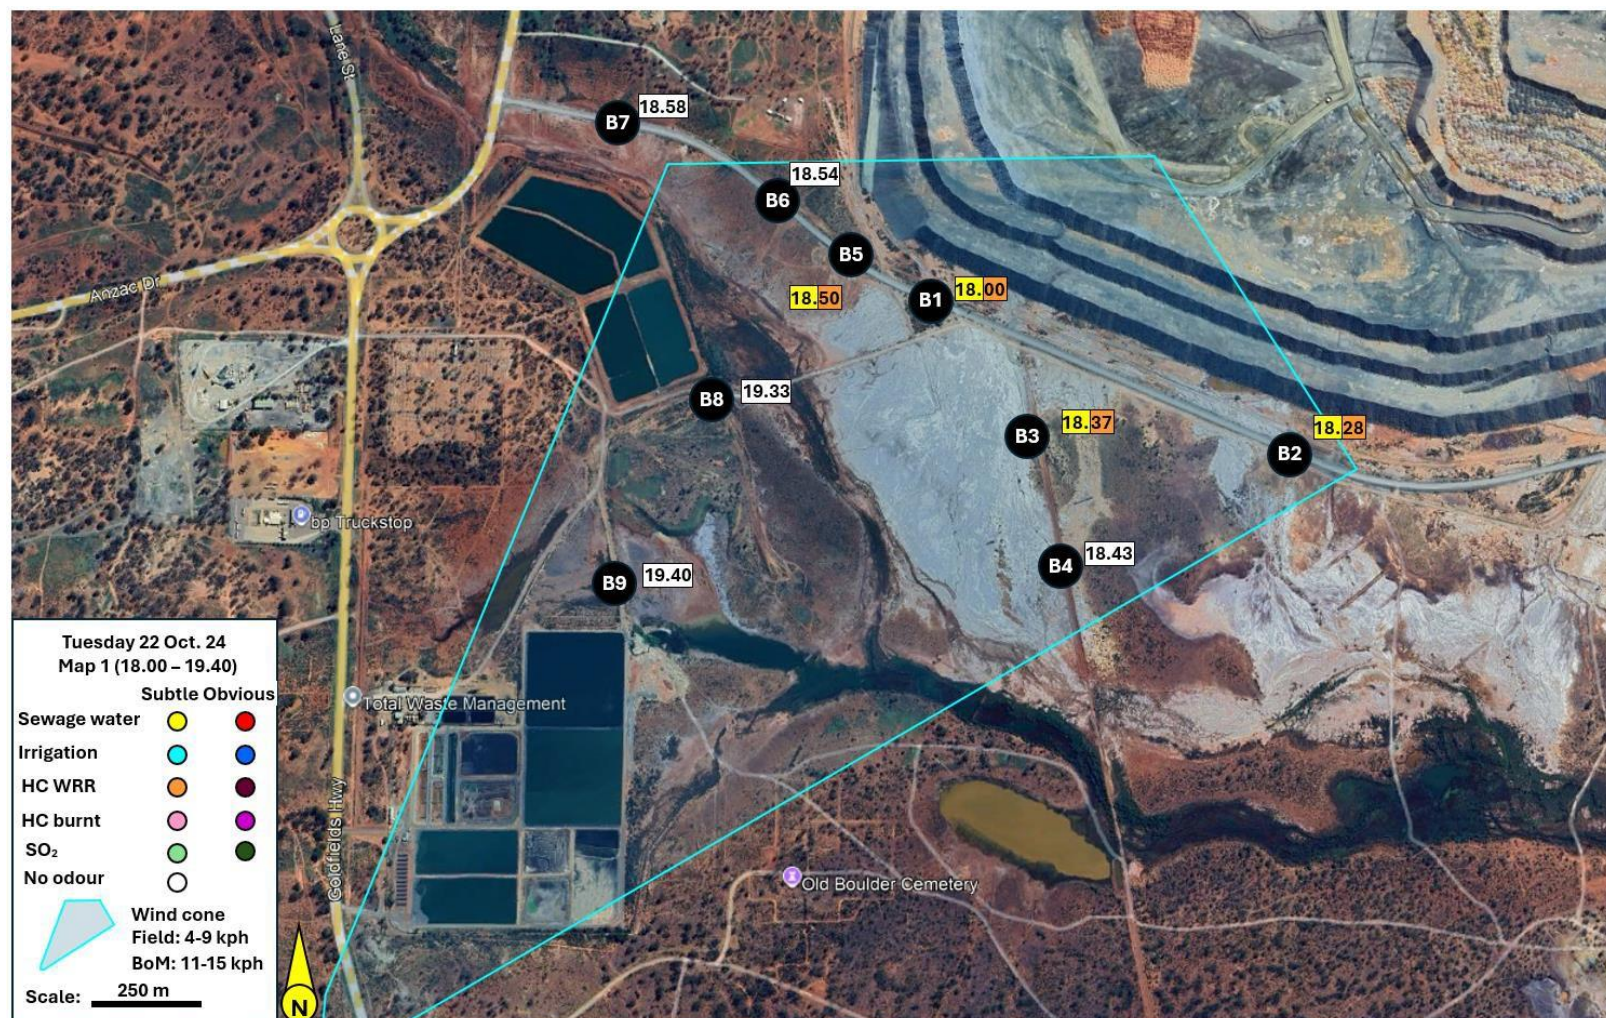
**Figure 18:** Odour map 1 OP #2

At 18.28, the same odour was detected at Point B2 at subtle level. Point B2 is situated 1,900m from WRR ponds and the SBWWTP lagoons 1A & 1B. Attribution to a specific source was not possible, and a similar bi-coloured marker was applied.

At 18.37, the odour was recognised at Point B3 at subtle level. B3 is located about 1,300m from WRR ponds and approximately 1,400m from the SBWWTP lagoons 1A & 1B. A reading of 4ppb of H<sub>2</sub>S by the Jerome equipment occurred at this point also. This suggests that part of the detected odour originated from the SBWWTP.

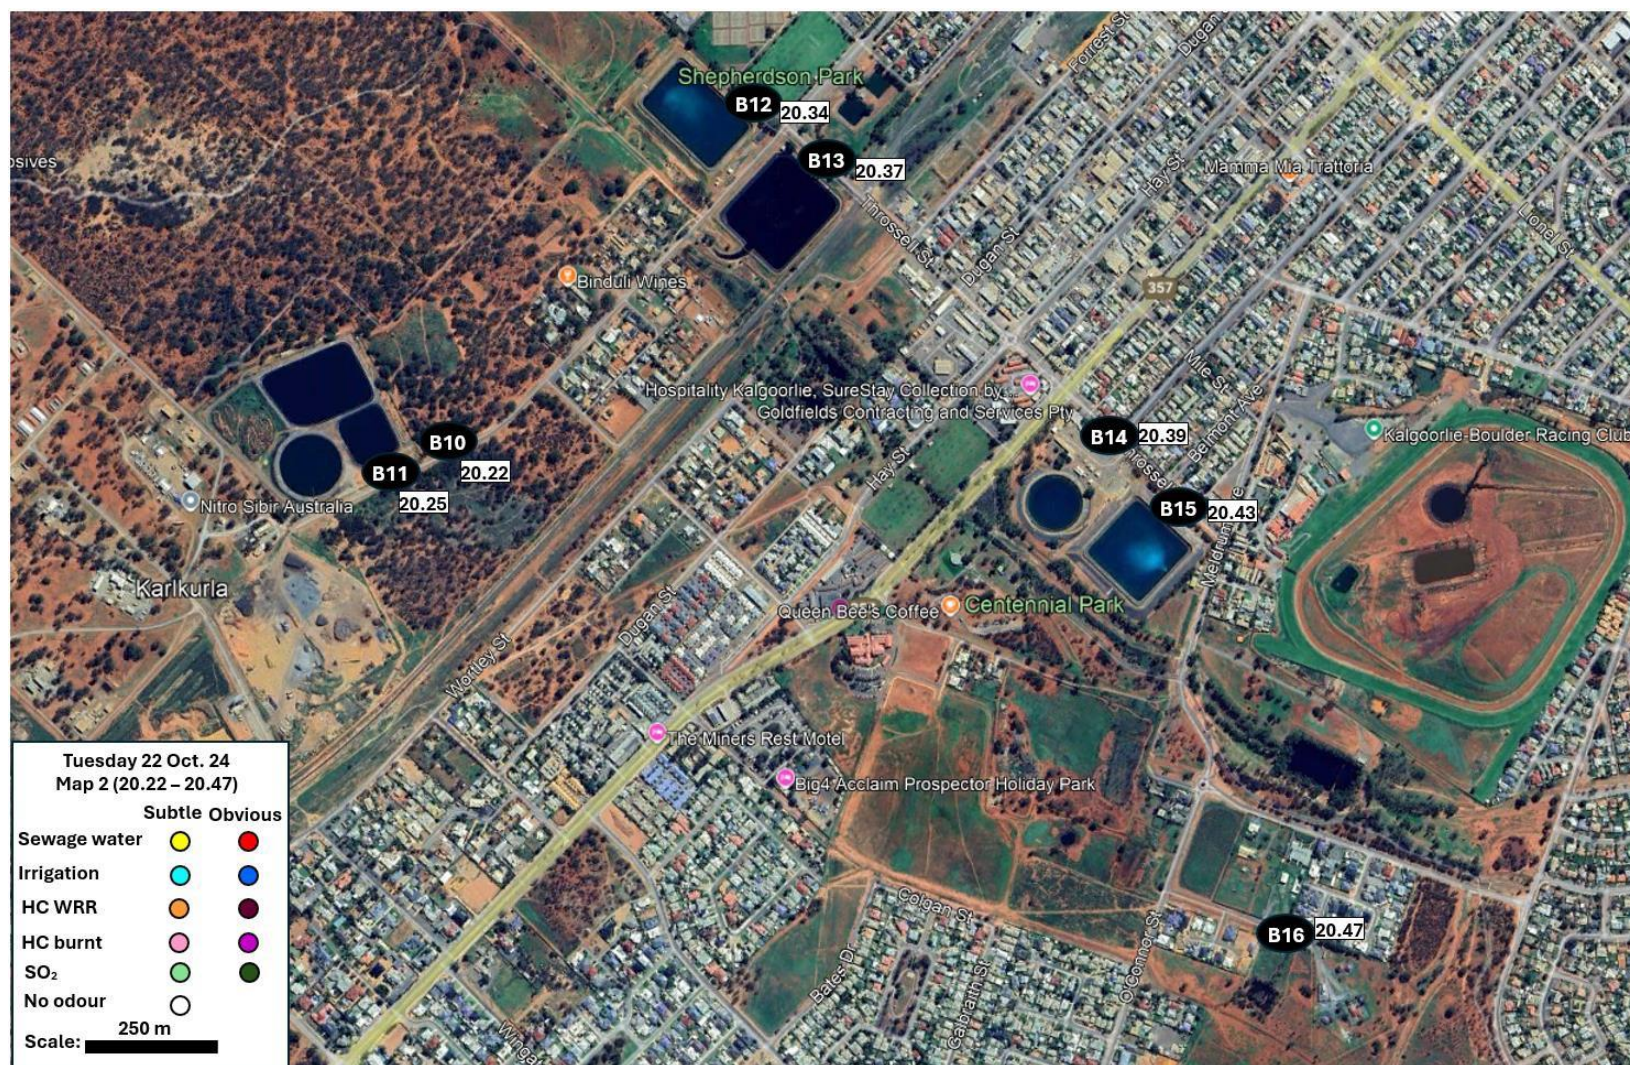
**Figure 19: Odour map 2 (OP #2)**

To investigate potential local sources, the industrial area bordered by Dwyer Street (north), Waverley Street (east), Goldfields Highway (west), and Pirie Street (south) was patrolled between 22.47 and 22.57. No odour was detected, and no site or activity was identified as a potential source of odour emissions.

At 23.00, no odour was noted near the BP petrol station under a southerly wind.

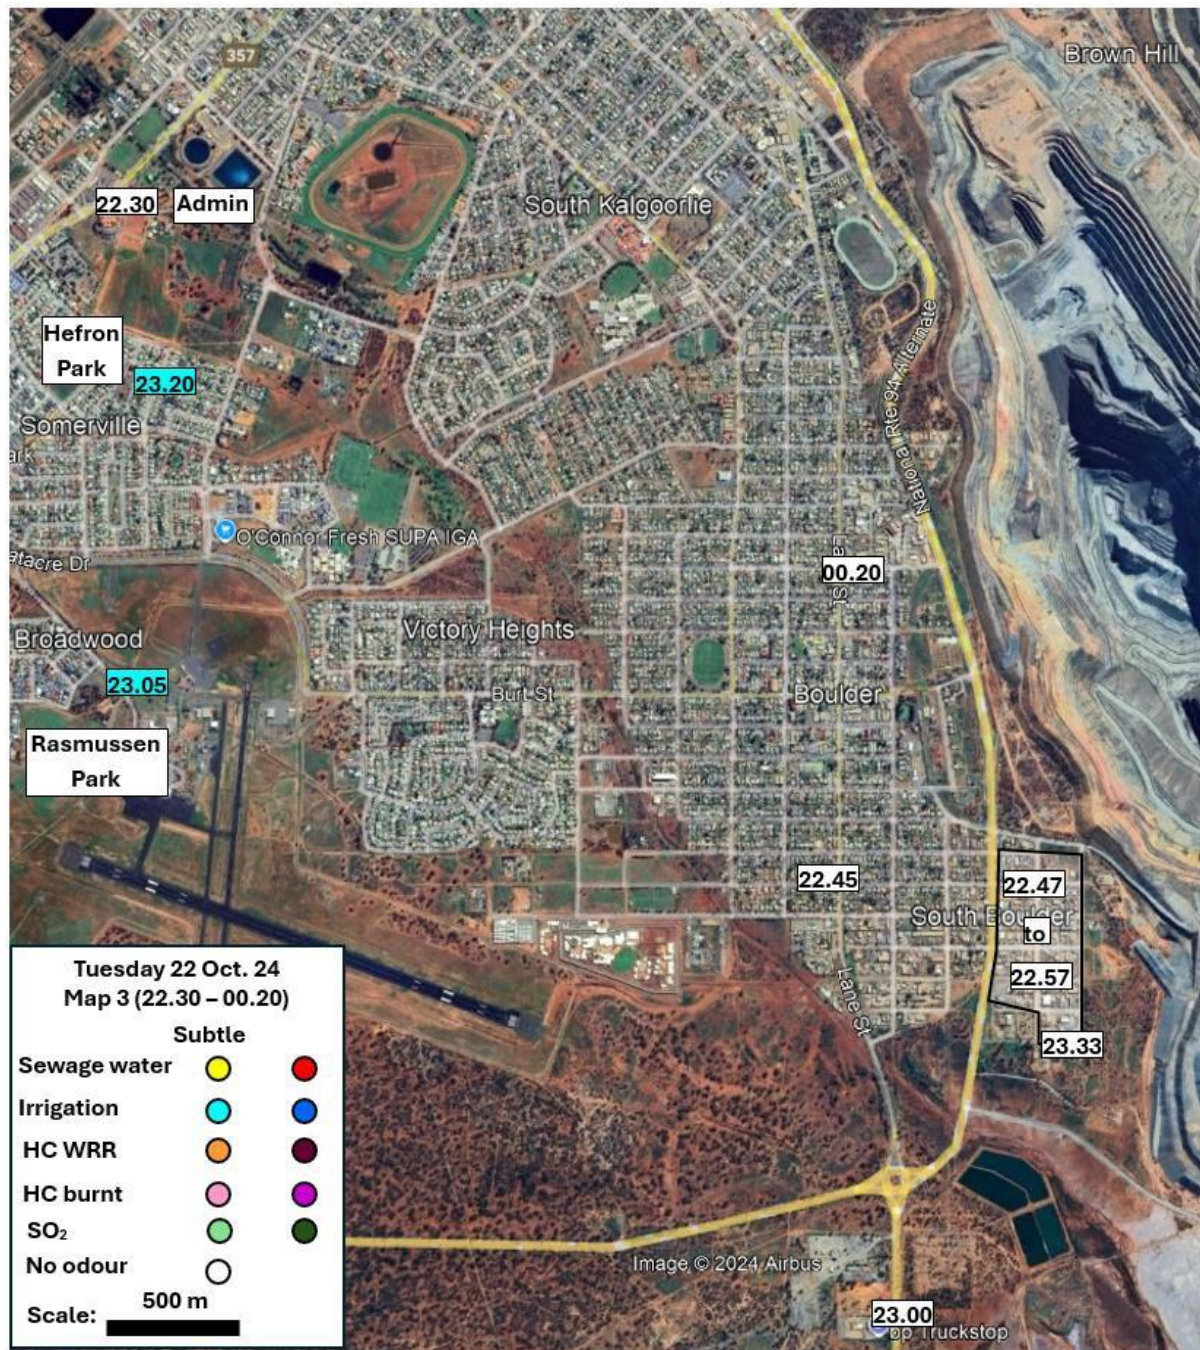
**Figure 20: Odour map 3 (OP #2)**

At 23.05, irrigation was in progress at Rasmussen Park. The water from the sprinklers emitted a subtle stale odour. By 23.20 at Hefron Park, the same odour with the same subtle intensity was observed. Samples of water from each park were collected in bottles, and the headspace of each was assessed the following morning, Wednesday 23 October 2024, with no prior odour exposure. The subtle stale odour was confirmed in both samples.

No specific odours or odour-emitting activities were identified during nighttime in the industrial area located south of South Boulder.
